Manhole Inspection Summary

Manhole # S03II2010MH

Insp Date: **7/10/06 1:34 PM**

Location Address: **6404 APOLLO DR**

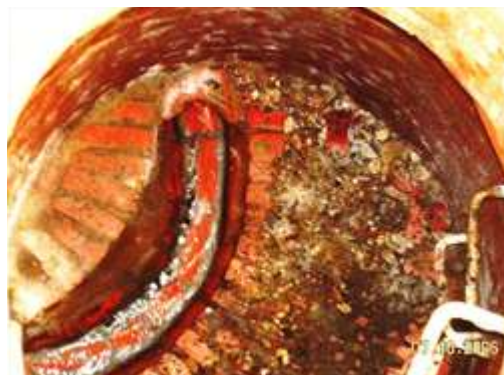
Top View

Frame Offset: **0** (in.) Condition: ☐ Sound ☐ Cracked ☒ **Leaks**

Infiltration: ☐ None ☒ **Joint** ☐ Cracks ☒ **Mortar** ☐ Roots ☐ Wall

Infiltration: ☐ None ☐ Joint ☐ Cracks ☒ **Mortar** ☐ Roots ☒ **Wall**

Surcharge ☒ **Evidence Of Surcharge** Depth: **1** (ft.) ☐ Active Surcharge Present

Frame leaks. Adjustment and Barrel infiltration. Evidence of surcharge - Bench debris.

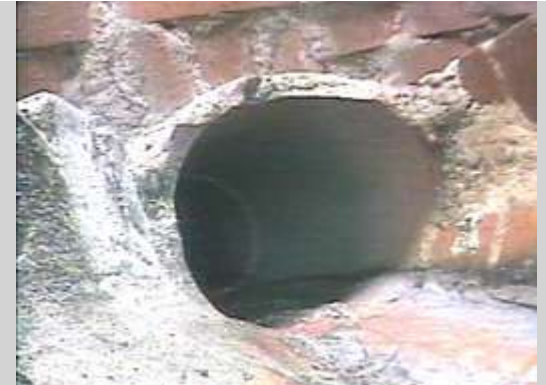
8 in. Circular Gravity Sewer Pipe Out @ 12 O'Clock

Pipe Material: **Clay** ☐ Pipe Lined

Invert Depth: **8.53** (ft.) Flow Characteristics: **Fast**

Deposits: ☒ None ☐ Mud ☐ Sludge ☐ Debris ☐ Grease

Infiltration: **None** Pipe Seal Cond: **Sound**

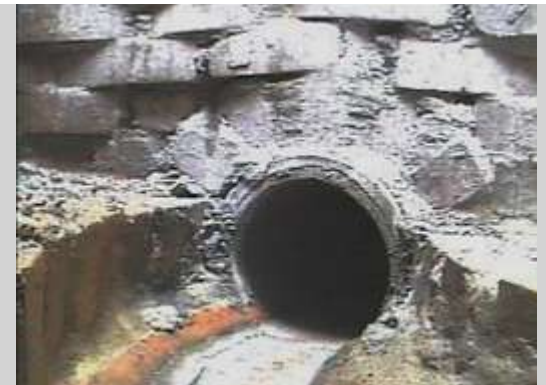
8 in. Circular Gravity Sewer Pipe In @ 9 O'Clock

Pipe Material: **Clay** ☐ Pipe Lined

Invert Depth: **8.34** (ft.) Flow Characteristics: **Fast**

Deposits: ☒ None ☐ Mud ☐ Sludge ☐ Debris ☐ Grease

Infiltration: **None** Pipe Seal Cond: **Unknown**
